RESEARCH HIGHLIGHTS

October 2003 Technical Series 03-129

MONITORING THE PERFORMANCE OF A RETROFITTED PRESERVED WOOD FOUNDATION

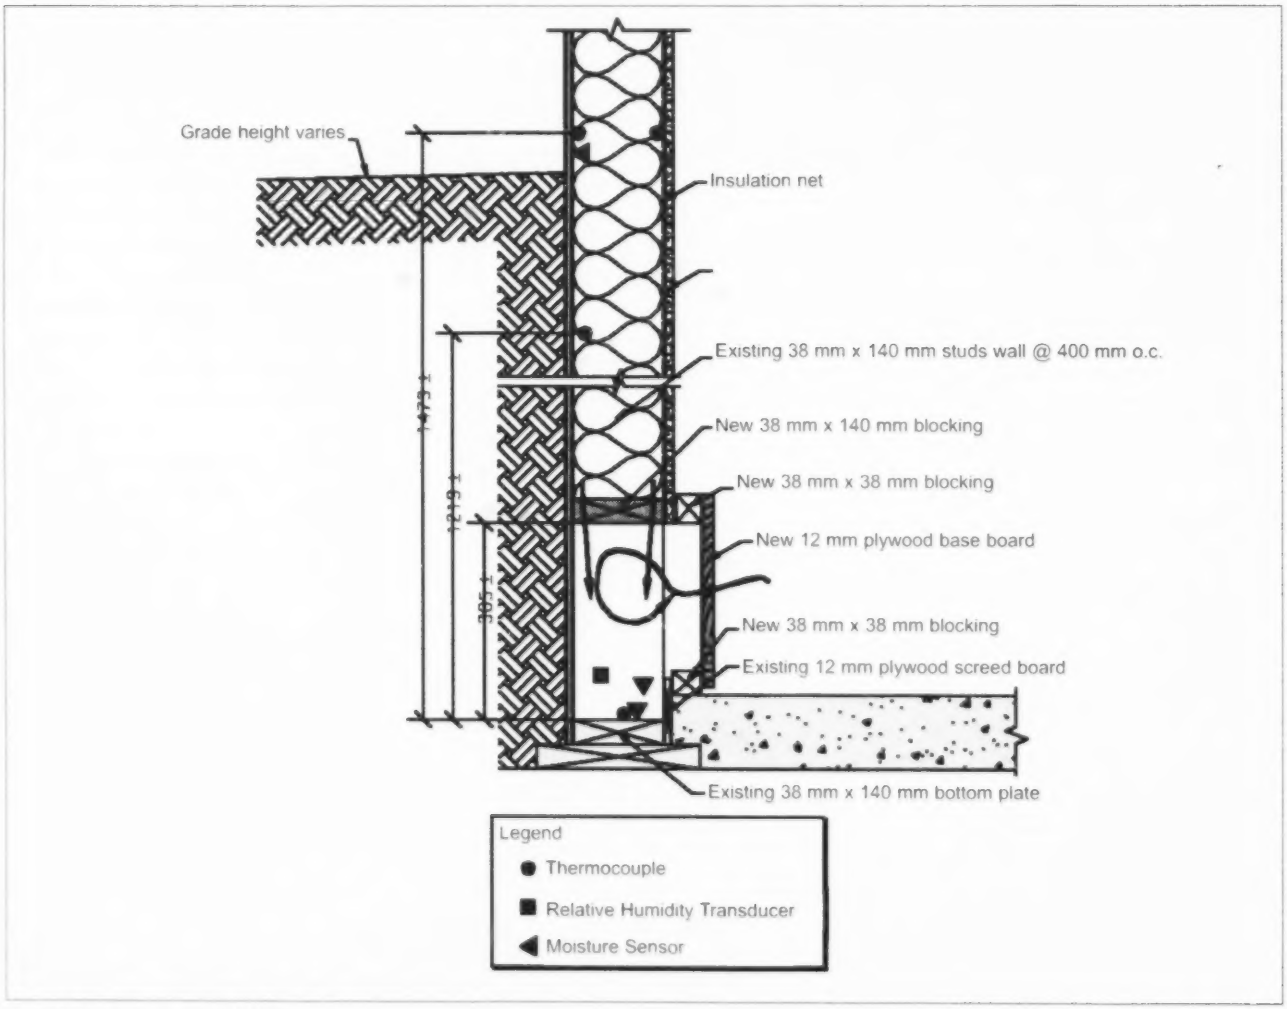
Figure 1. Typical cross-section of PWF wall.

Figure 1 shows a typical cross-section of the wall and ventilation cavity, and the location of sensors. The primary findings drawn from this monitoring project were:
